Navajo Abandoned Uranium Mine

Site Screen Report

Saytah Canyon AUM Site

Weston Solutions, Inc.

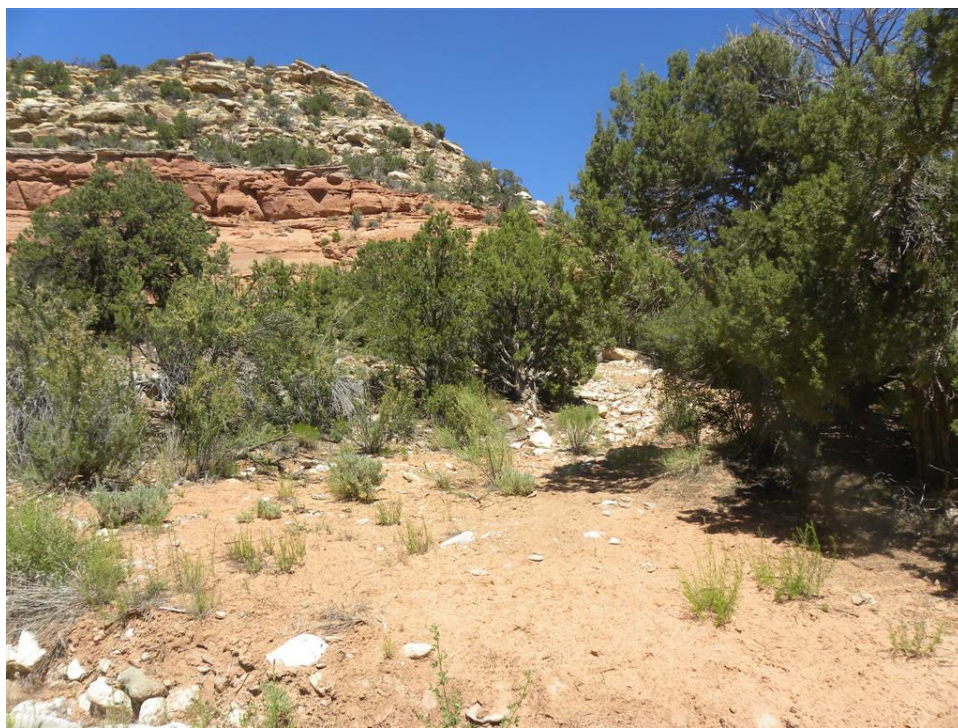
Photo 3. Saytah Canyon site #218

#218 – Reclaimed work area with stone marker

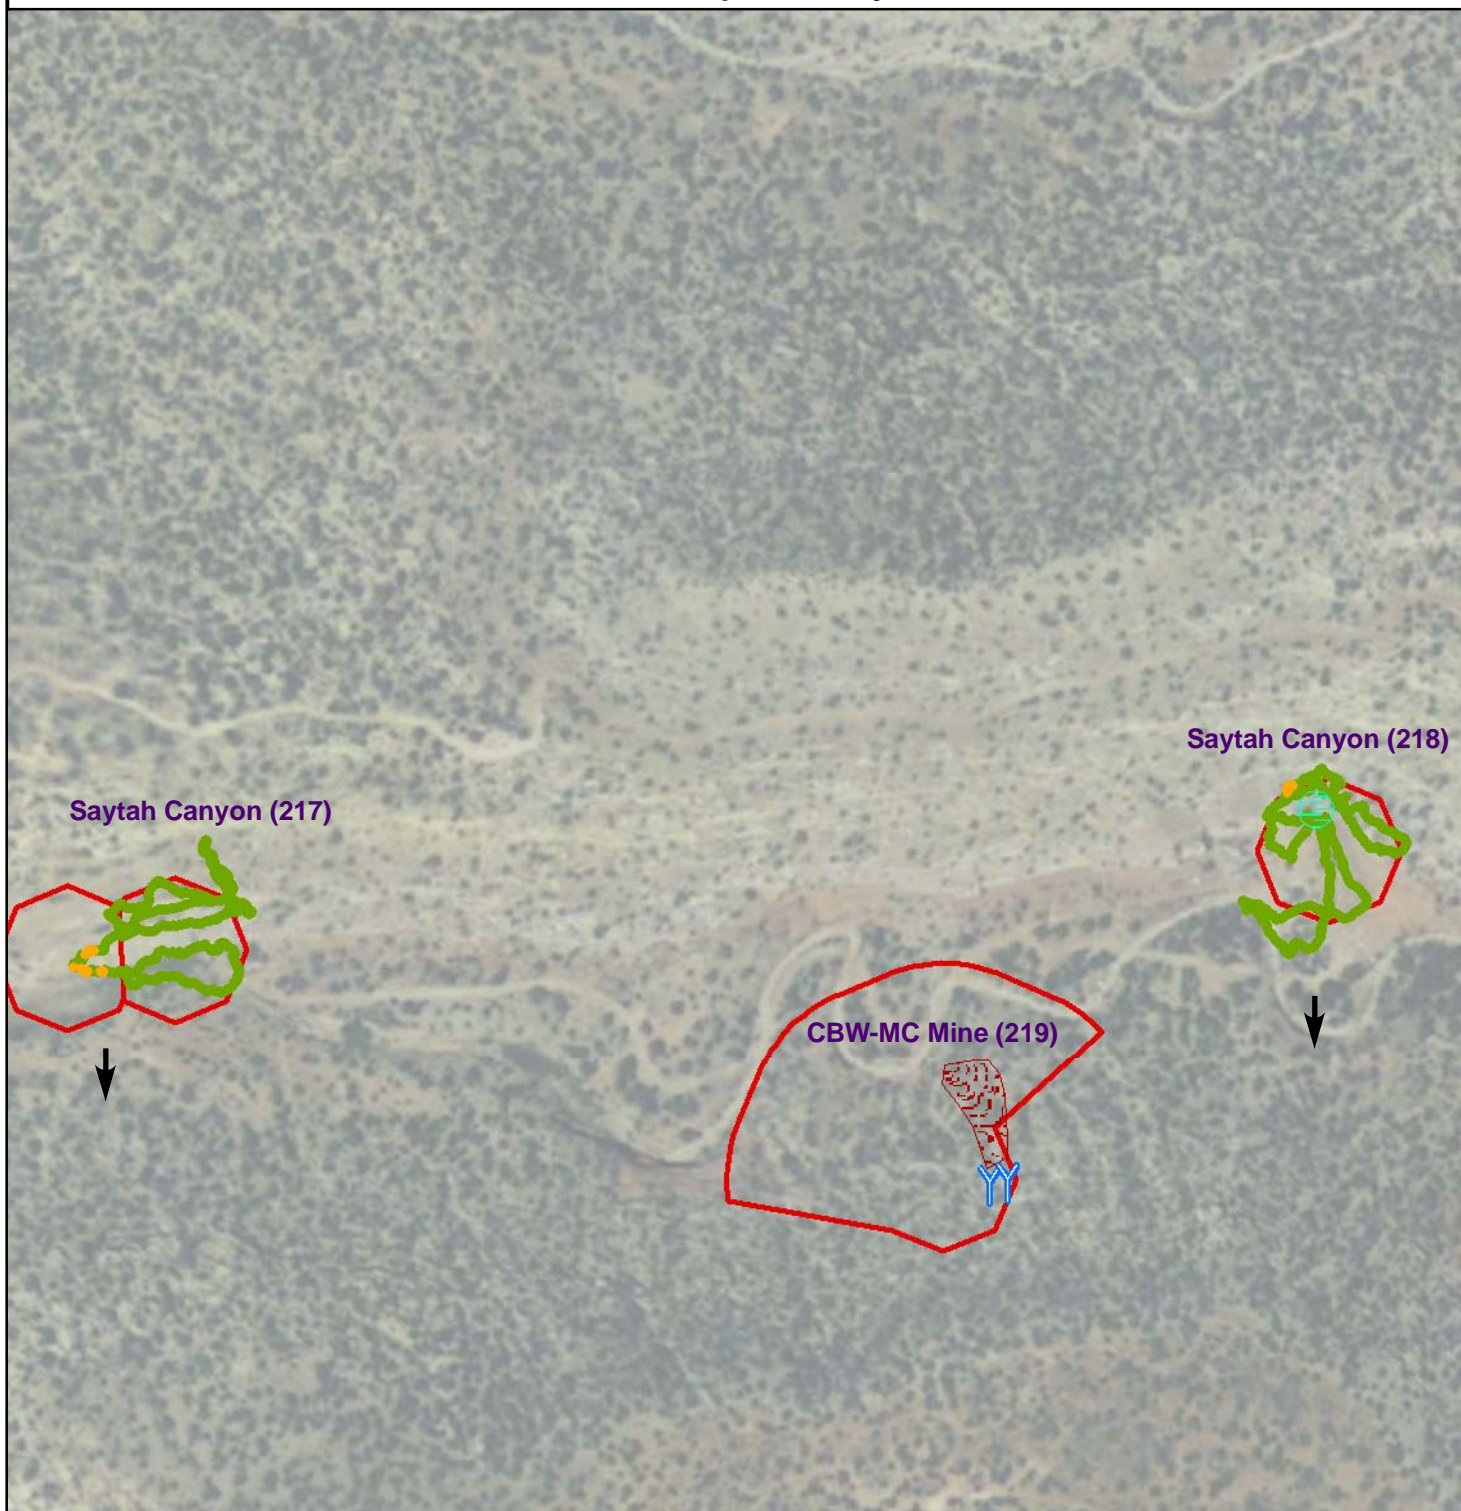
**Figure 1 - Gamma Radiation Measurements, Above Two Times Background
Saytah Canyon (217, 218)
Sweetwater Chapter, Navajo Nation**

Gamma survey conducted 06/2010
Measured as counts per minute (cpm)

Average background = 10,802 cpm

A total of 977 gamma radiation measurements were collected from the mine site, ranging from 7,055 cpm to 26,260 cpm. The measurements are represented in Figures 1 and 2.

A total of 1,088 gamma radiation measurements were collected from the mine site, ranging from 6,517 cpm to 56,111 cpm. Measurements collected in the vicinity of the reclaimed area were found at levels up to approximately 30,000 cpm. The measurements are represented in Figures 1 and 2.
